MPW Restores Vintage Warehouse Following Fire and Smoke Damage

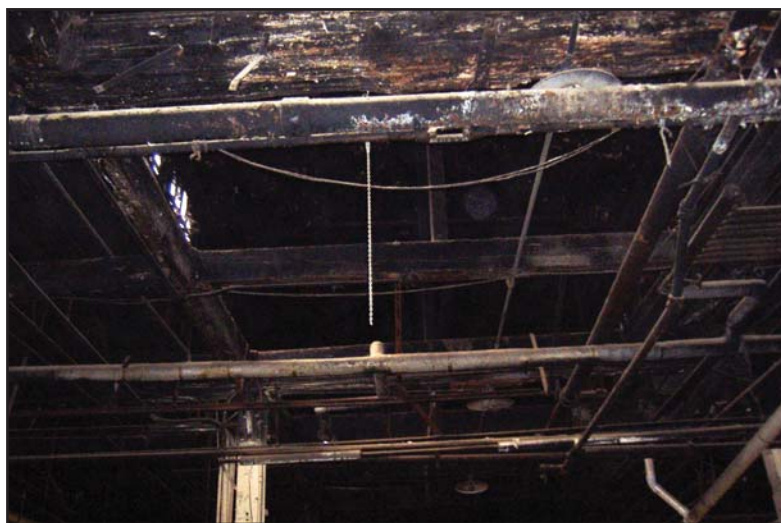
A team of MPW specialists responded immediately to the scene of destruction to determine the extent of damage, scope of work required and scheduling of crews. MPW safety personnel inspected structural hazards that needed to be addressed prior to executing the restoration project.
