Best Practices Guides

Our Environmental Management team recently launched a new internal program designed to improve our overall customer service, safety and efficiency processes called our Best Practices Guides. Devised during our regular safety committee meeting, our team uses real customer scenarios to track some of our unique success stories/safety challenges in order to utilize them when similar client needs arise. Creating an internal repository of such guidelines helps us streamline our problem-solving process and provides our customers with access to our very best solutions.

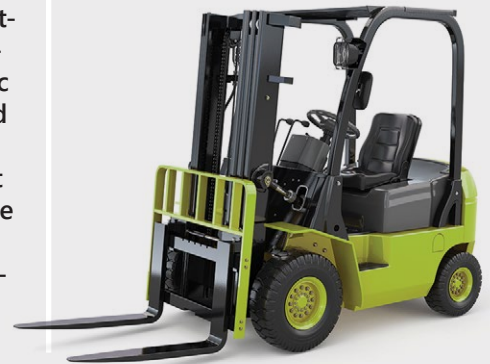
FORKLIFT LIFTING BEAM AND CHAIN

While conducting a safety audit for an environmental recycling center, an MPW team member asked about the company's process for lifting and draining scrap transmissions and engines. The technician indicated that their previous waste management partner would lift the transmission with a chain that was wrapped around a forklift fork – or a process known as “free rigging.” As free rigging is not an approved or safe practice, MPW's environmental team recommended using a lifting beam that could be easily attached and removed from the forklifts to safely move the engines and transmissions from their dunnage for the purposes of scrapping them. When utilized properly with the chain sling, this process is safe and in compliance with regulations and safe work practices.
