MPW's Jacket Water Cleaning Reveals Hidden Threat

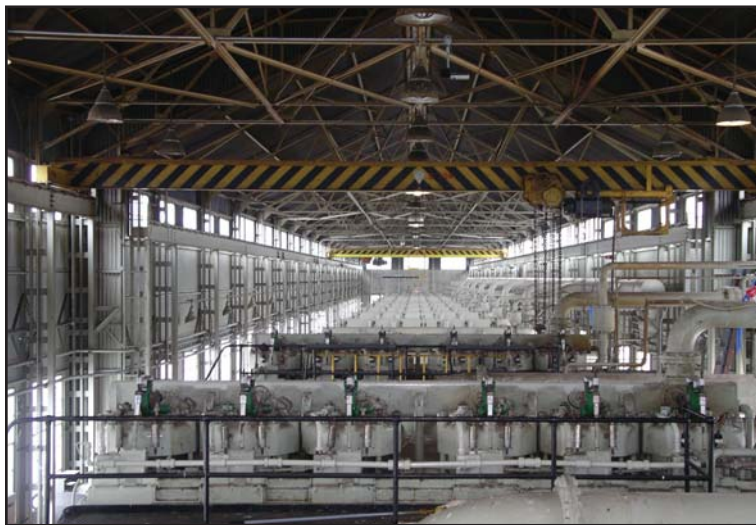
MPW technical support delivers over 125 years combined operations and applications expertise to effectively clean glycol cooling loops and jacket water systems. MPW manages all aspects of draining, filtration, flushing and refilling. Chemical and mechanical cleaning methods ensure that unit life expectancy is increased, heat transfer is improved and flow is restored.

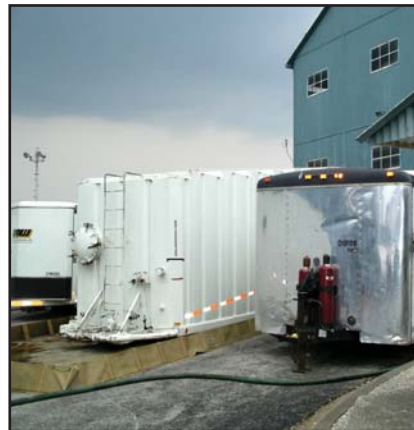
Solubility studies are conducted utilizing various chemical formulations. MPW's fleet of mobile jobsite laboratories are built in-house to provide rapid, highly accurate chemical analyses.
