Remote-vacuuming technology makes white liquor tank cleaning safer, more efficient

REMOTELY-OPERATED, AUTOMATED CRAWLER ELIMINATES CONFINED-SPACE ENTRY

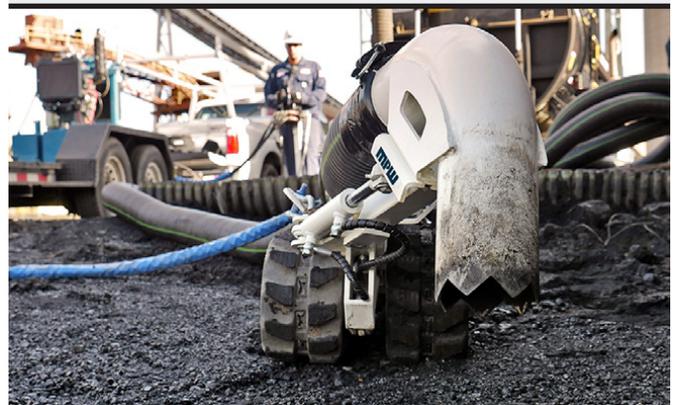
Custom-designed and fabricated by MPW engineers, the M1-RV is an automated vacuuming system. This tool increases cleaning efficiencies and eliminates the need for technicians to enter potentially dangerous confined space areas. The versatile M1-RV vacuums in conjunction with a high-pressure water nozzle and an auger, fracturing solid debris for easier removal. Using a video monitor, technicians aim the spray and adjust the nozzle with a mechanism that works similarly to a joystick.

The M1-RV was a smashing success, completing the tank cleanse without the need for additional water jetting. The most important aspect of the project was the avoidance of human entry into the white liquor tank. The M1-RV was unfazed when a large chunk of the white liquor broke loose and fell onto the robotic base. Workers present at the time said the incident would have likely led to an injury if a worker had been in the tank.
